## Chapter 9

# FIRE BEHAVIOR IN WORLD TRADE CENTER 2

### 9.1 INTRODUCTION

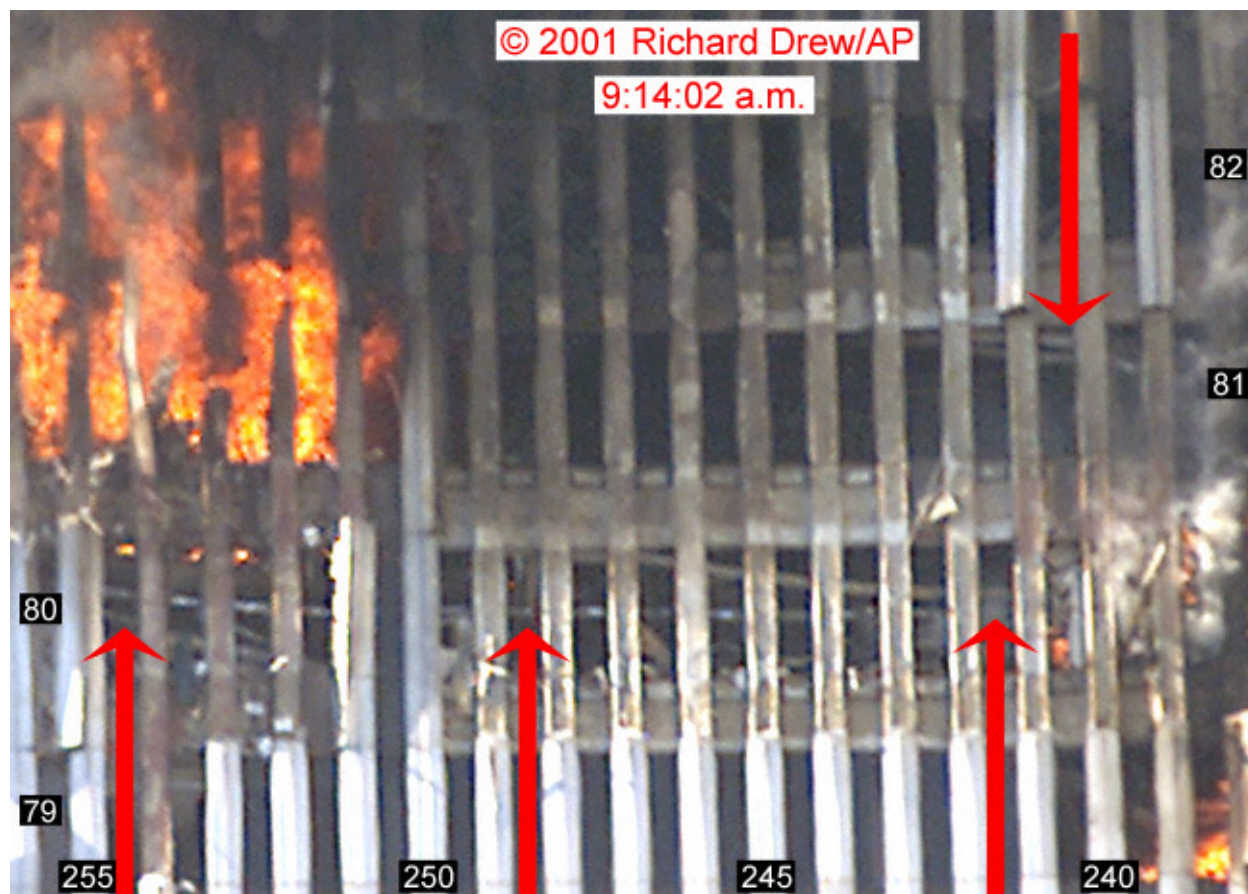
In Figure 9-16 and Figure 9-17, small fires are visible above the longest hanging object seen through windows on the 80th floor at the tops of window 80-248 and windows 80-252 to 80-254, again suggesting that fuel located on top of the hanging objects is burning. The large fires nearest the eastern edge on the 81st and 82nd floors and in the opening on the northeast corner continue to burn intensely in the same windows as earlier. In Figure 9-16, it appears as if a fire is burning on the 83rd floor in window 83-257, but it is possible that these flames are an extension from the large fire on the 82nd floor. There is evidence in the photograph for strong heating of the façade at the base of the 83rd floor in this area. The lower portions of the aluminum covers on columns 83-256 to 83-259 are missing, and the bottom edges of the remaining aluminum have an inverted “v” shape. These observations indicate that these aluminum column covers have been melted by the intense heat coming from below.

**Figure 9-17. A section of the image shown in Figure 9-16 is blown up. The arrows point to the locations of hanging objects that are visible through open windows on the 80th and 81st floors on the north side of WTC 2.**

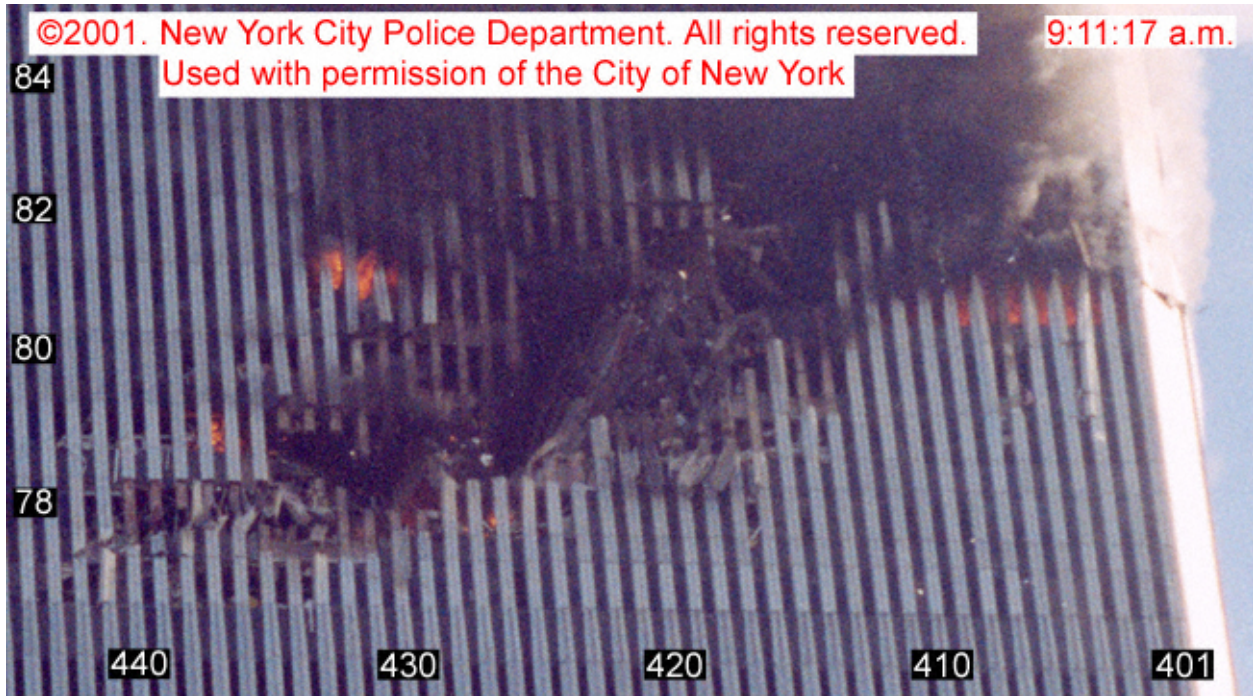
A view of the south face of WTC 2 at 9:11:17 a.m. is shown in Figure 9-18. It was taken approximately 4 min after the images shown in Figure 9-10 and Figure 9-11. During this time a large fire has appeared on the 81st floor to the east of the aircraft impact cavity. Flames are now visible on this floor in windows 81-401 to 81-409, and heavy smoke is coming from the area. Given the apparent intensity of this fire, it is noteworthy that there continues to be no indication of a fire, i.e., smoke and/or flame, from adjacent windows on the east face at this time. Figure 9-15, which was taken nearly a minute later, shows that this is the case.

Comparison of Figure 9-10 and Figure 9-18 indicates that the fires ignited at other locations within and immediately adjacent to the aircraft impact cavity have continued to grow and spread slowly. At the earlier time, the glass in window 81-431 appeared to be intact, while in Figure 9-18 flames are coming from this window and are visible in window 81-432 as well. The appearance of the fire burning on the debris pile located at the western edge of the aircraft impact cavity on the 79th floor is similar to that seen earlier, while the fire on the 78th floor seems to be slowly spreading across debris piled within the cavity.

**Figure 9-18. This cropped photograph shows the south face of WTC 2 at 9:11:17 a.m. The image has been rotated and enhanced by adjusting the intensity levels. Column and floor numbers have been added.**

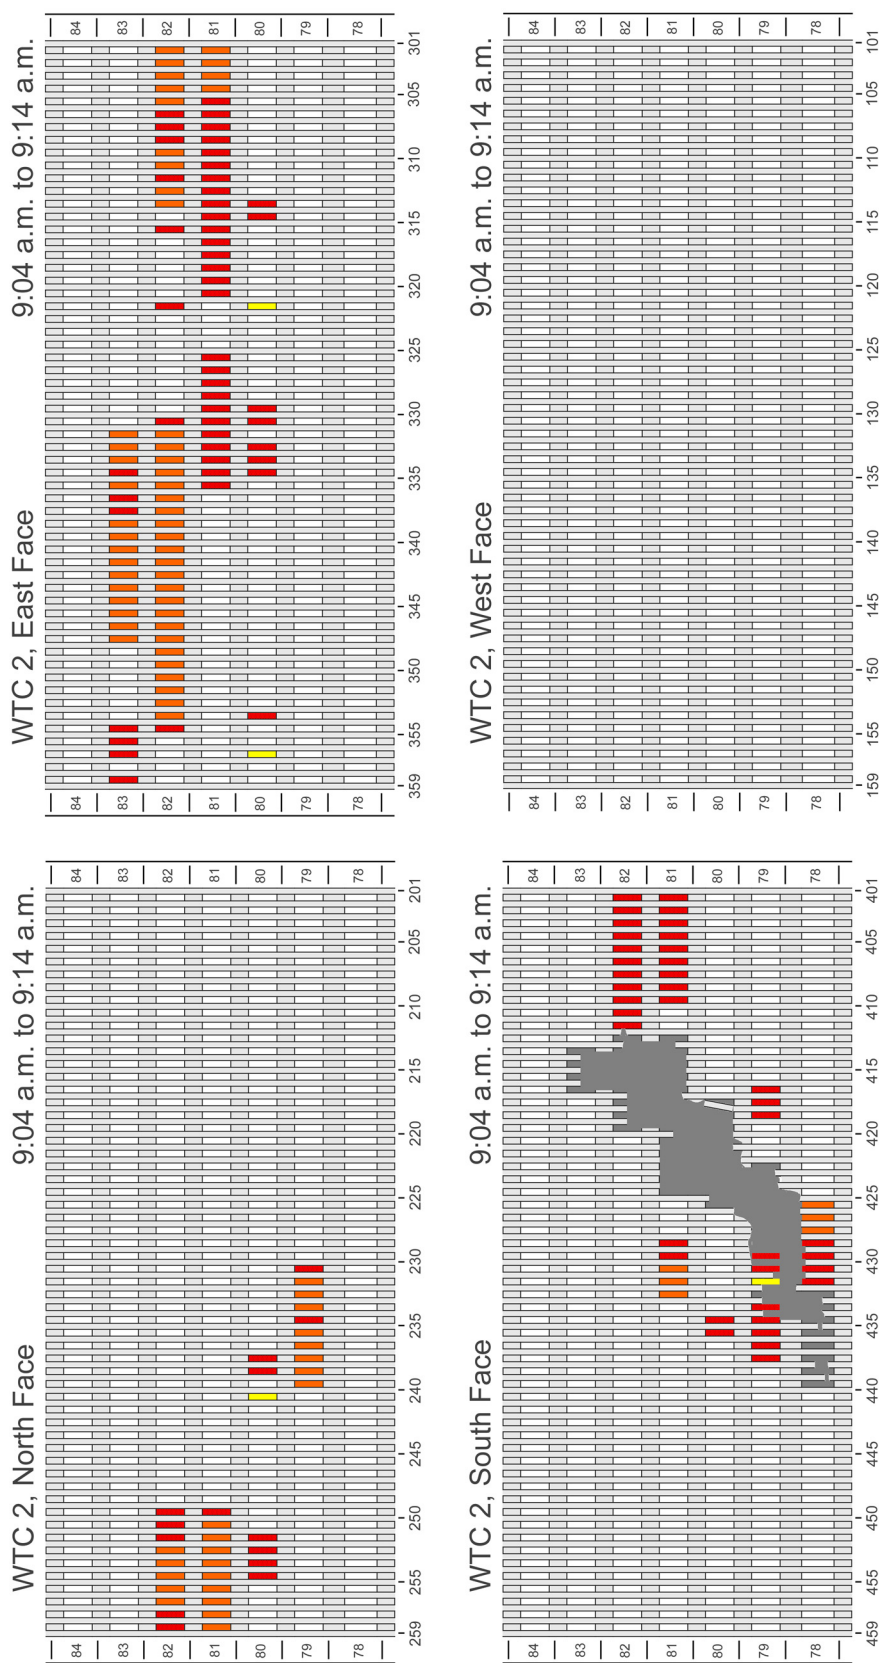
Major observations concerning the fire behavior in WTC 2 during the initial twelve minutes following the aircraft impact are summarized here. The datasheets for the fires have been integrated by identifying the most intense fire observed in a given window during the period. The results are shown graphically in Figure 9-19 for the four faces of WTC 2. The same cautions concerning datasheet accuracy apply as discussed in the preceding chapter with regard to WTC 1. Nevertheless, Figure 9-19 should prove

On the north face large fires were initially ignited on the eastern edges of the 81st and 82nd floors and at a location more toward the center on the 79th floor. On the 79th and 81st floors these fire were burning on large piles of debris located just inside the façade. These fires continued to burn intensely during the entire period. There was little indication of fire spread or additional growth. Little smoke and flame were observed in an area of the façade, covering the 80th, 81st, and 82nd floors and extending from column 238 to column 250, lying between the fires on the 81st and 82nd floors and the fire on the 79th floor. This area is referred to as the cold spot.

Immediately following the aircraft impact, extensive fires were visible on the east face over the northern halves of the 81st and 82nd floors and on the southern portion of the 83rd floor. An intense fire was also burning within the debris-filled opening created in the northeast corners of the 81st and 82nd floors by the aircraft impact. Smaller isolated fires were present on the 80th floor. The fire on the southern side of the 83rd floor died down rapidly, while a large fire appeared and rapidly grew on this side of the 82nd floor. The fires on the northern ends of the 81st and 82nd floors and in the northeast corner continued to burn vigorously during the entire period. Only small fires were visible on lower floors.

**Figure 9-19. Maps of integrated fire observations between 9:04 a.m. and 9:14 a.m. are shown for the four faces of WTC 2. Colors represent the highest intensity fire observed in a window using the color scale defined in Figure 5-1.**

Several small fires were visible on the south face shortly following the aircraft impact. These fires were located within the aircraft impact cavity and immediate adjacent areas. During the period considered here, these fires spread and grew relatively slowly. The only visible area of extensive fire spread was on the eastern side of the 81st floor, where a large fire grew between 9:07 a.m. and 9:11 a.m., and immediately above on the 82nd floor, where a fire was observed just prior to 9:15 a.m., after the fire on the 81st floor had died down.

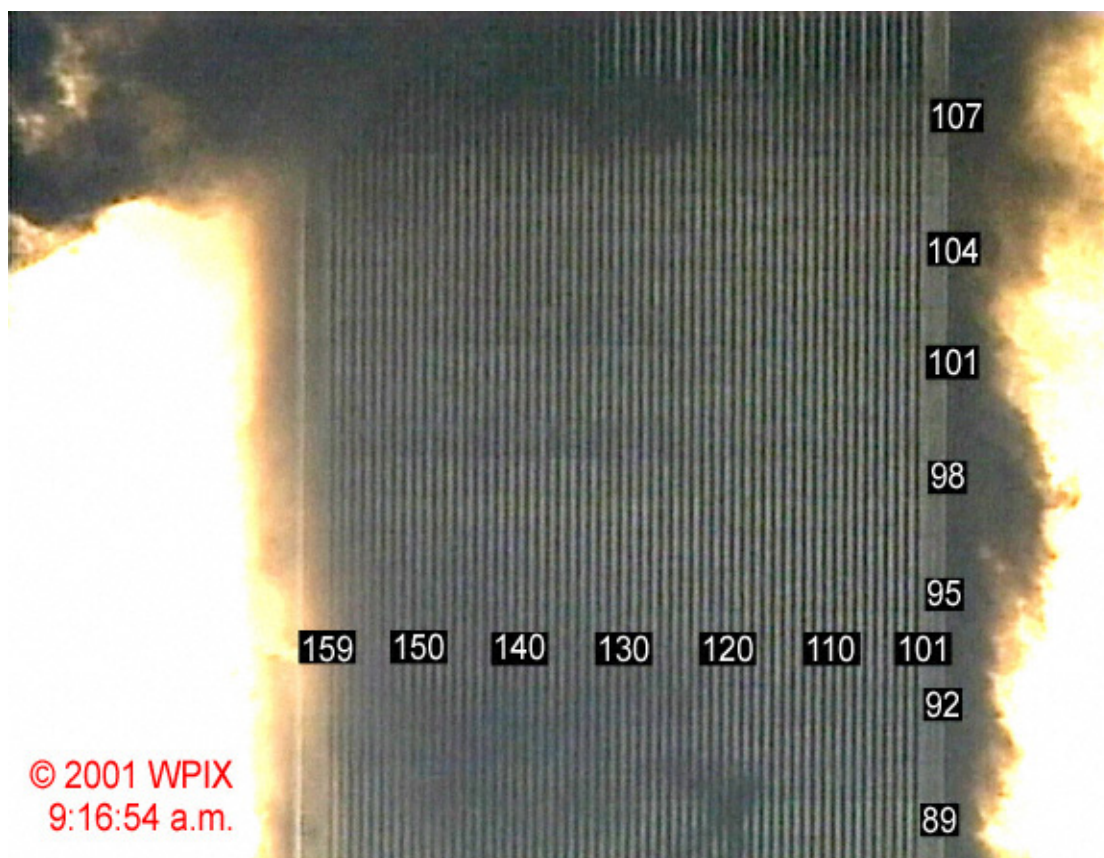
The observations from the video indicate that several additional windows located on the 86th floor had broken out since 9:10:29 a.m. It also appears that heavy smoke had traveled to the top of the tower, and people on the 107th floor broke out windows.

**Figure 9-20.** This image of the west face of WTC 2 was captured from a video shot from a news helicopter at 9:16:54 a.m. It has been enhanced by adjusting the intensity levels, and bright areas to the right and left of the tower are saturated. Column and floor numbers have been added.

The hanging object on the 81st floor is now visible through windows 81-331 to 81-335 and windows 81-338 to 81-342. Windows further to the north remain obscured. Comparison of the location of the object with the image reproduced in Figure 9-1 and Figure 9-2, which was recorded at 9:03:42 a.m., shows that the object is at roughly the same height in the windows and has a similar shape.

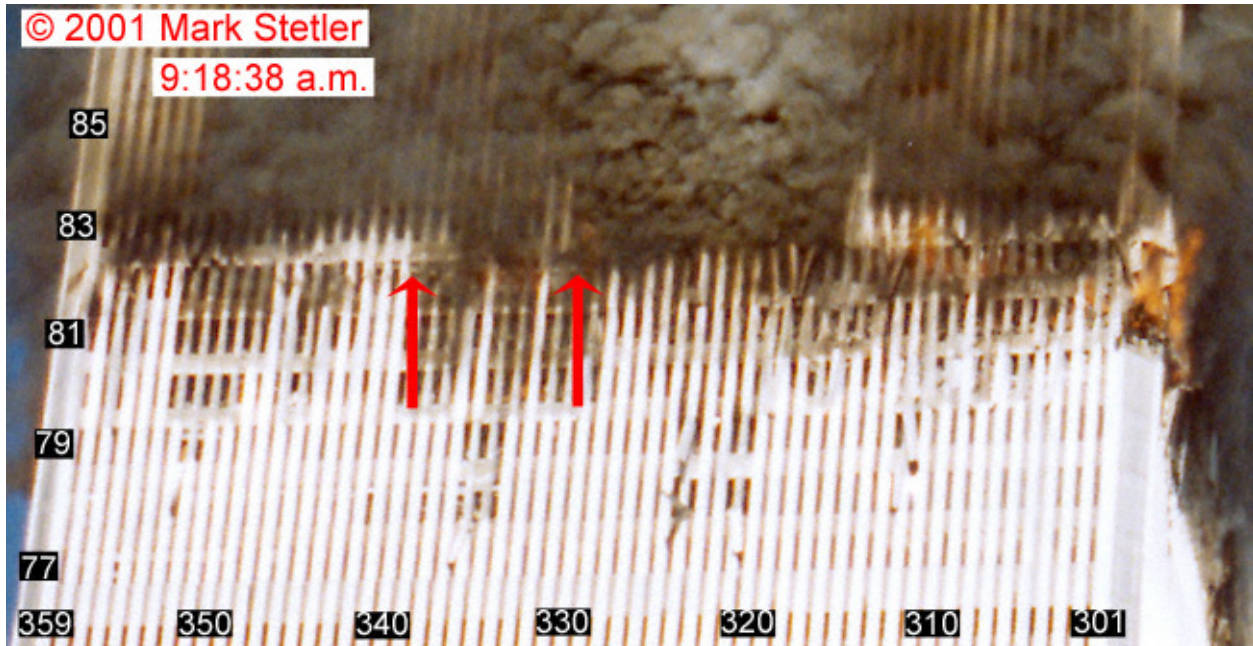
A photograph of the east face of WTC 2 at 9:18:38 a.m. is shown in Figure 9–21. It was taken almost 6½ min after the photograph reproduced in Figure 9–14 and Figure 9–15. Comparison with the earlier images indicates that the fire burning on the southern side of the 82nd floor has subsided during the intervening time. At the earlier time, intense flames completely filled windows 82-333 to 82-342 and hid the hanging object that had been visible in this area shortly after the aircraft impact. As indicated by the arrows added to Figure 9–21, the object was once again visible at 9:18:38 a.m. A review of photographs and videos recorded during the intervening period indicated that the view of this area had gradually

The fires on the northern edges of the 81st and 82nd floors and in the opening on the northeast corner continue to burn intensely at a level comparable to that seen at 9:12:11 a.m. in Figure 9-14. There is still very little indication of a fire near the southern edge of the 81st floor. A small fire remains on the 80th floor near window 80-335. Heavy flows of smoke continue from the southern side of the 83rd floor and from near the center of the 82nd floor.

In the photograph taken at 9:18:38 a.m. there is no indication of significant smoke flow on the east face from windows lower than the 82nd floor. This was generally true around this time, but was not always the case. Starting around 9:12:45 a.m. a series of short-lived, apparently coordinated smoke releases were observed in which smoke was pushed out of multiple open windows on the 79th, 80th, and 81st floors.

**Figure 9-21. View of the east face of WTC 2 recorded at 9:18:38 a.m. The original photograph has been cropped and enhanced by adjusting intensity levels. Column and floor numbers have been added. The arrows highlight a hanging object observed through open windows on the 82nd floor.**

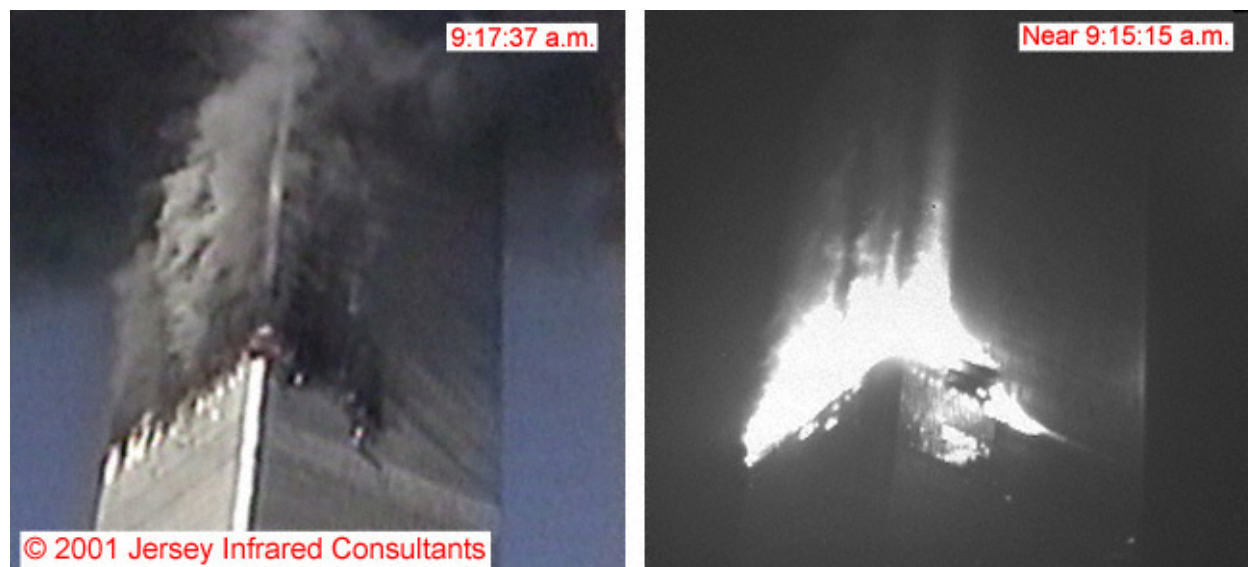
Figure 9-22 and Figure 9-23 include infrared images of WTC 2 that were shot around 9:15:15 a.m. and 9:17:20 a.m., respectively, from northeast of the WTC site. Time uncertainties are estimated as 15 s. Figure 9-22 also includes a frame taken from a standard video that was shot from the same vantage point at 9:17:37 a.m. The size and orientation of the video frame has been adjusted to match the infrared photograph, allowing relative locations on the infrared photograph to be identified. The image in Figure 9-23 was created by connecting the output of the infrared camera to the input of a standard video camera. The infrared camera was set to output a false-color scale for temperature, unlike the grey scale used for the image in Figure 9-22. Recall from the discussion in Section 8.1 that the temperature scales for the infrared images are not quantitative and that they provide only a relative indication of the amount of heating at a given location. Much of the heated area is saturated in the infrared images.

The most striking feature in the infrared image shown in Figure 9-22 is the dark region between the two bright areas on the north face. The low level of infrared emission coming from the dark region indicates that the temperature of this portion of the facade is close to the outside ambient temperature. By comparing the infrared image with normal images of the north face, such as that shown in Figure 9-16, it can be seen that the unheated region is located in the same area of the face that has been identified as the cold spot. It is clear that not only is the cold spot mostly free of smoke and fire, but that it is very nearly at room temperature, despite the presence of nearby fires on either side. The area is indeed a “cold spot” relative to its immediate surroundings.

Figure 9-22. This figure compares an infrared photograph (on the right) and an image of WTC 2 captured from a video that was shot from the same vantage point and scaled and oriented to match the infrared shot. The north and east faces of the tower are visible. The video frame was shot at 9:17:37 a.m., and the infrared image was taken around 9:15:15 a.m. (an uncertainty of 15 s has been assigned).

The cold spot does not appear to have a completely rectangular shape in Figure 9–22. There is a slightly heated area at the upper left corner that is most likely due to the flames on the 82nd floor that are visible in window 82-249 in Figure 9–16. Similarly, there is small heated region in the lower right corner on the 80th floor that is most likely associated with the small fire burning on the debris pile in window 80-241.

By using the heated areas within the cold spot as markers, it is possible to correlate other parts of the infrared image with Figure 9–16. The bright area below and to the west of the cold spot is the fire visible over many windows on the 79th floor. The narrow lighter line that extends westward from the brightest region indicates that heat is being transported across the floor, even though imagery indicates that these windows were still in place in the area. Similar heating is also apparent on this floor below the cold spot. A narrower bright region above the 79th floor reflects the fire burning on the pile of debris on the 80th floor that can be seen in Figure 9–16.

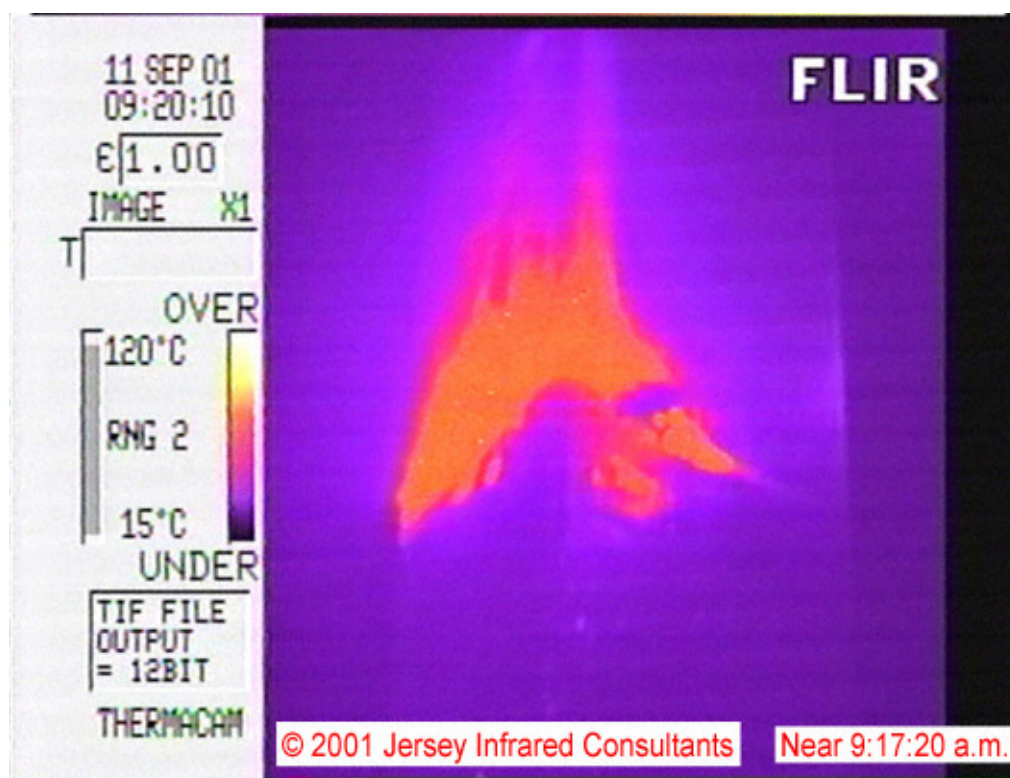
Figure 9-23. This image shows a frame from the false-color output of an infrared camera that was connected to a standard video camera. The time was around 9:17:20 a.m. (an uncertainty of 15 s is assigned). Blue represents the coolest temperatures and red the warmest temperatures.

Even though the exact times when Figure 9-22 and Figure 9-23 were taken are not available, it is known that the image in Figure 9-23 was taken 2 min and 4 s after Figure 9-22 was shot. The false-color image in Figure 9-23 is more saturated, but it is clear that the heat distributions on the north and east faces are similar to those described for Figure 9-22. This indicates that the thermal distributions on the north and east face of WTC 2 changed relatively slowly around this time.

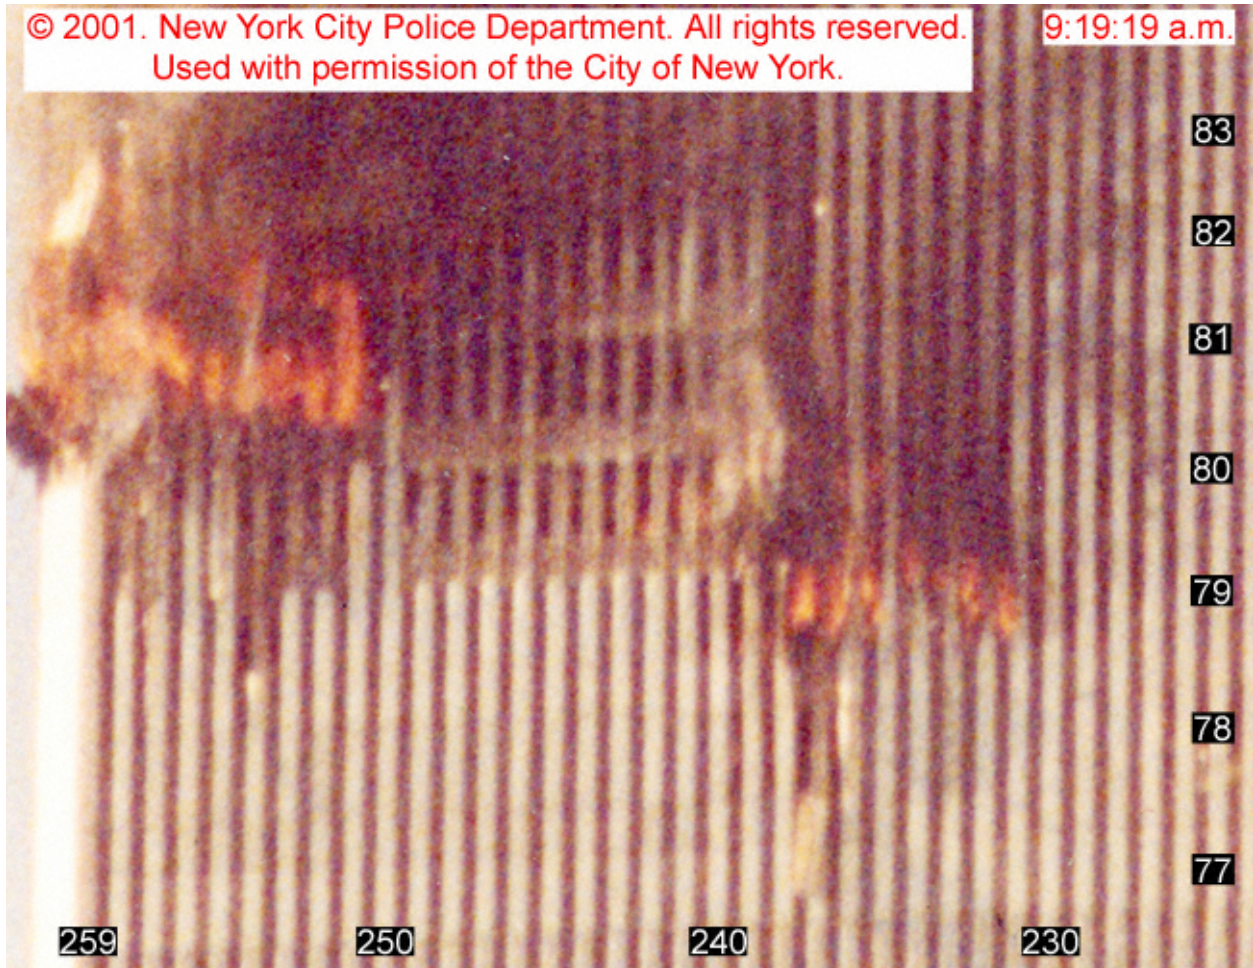
A photograph showing the fire areas on the north face of WTC 2 at 9:19:19 a.m. is reproduced in Figure 9-24. This image was taken just over five minutes later than that shown in Figure 9-16. Even though the later image is not as resolved, it is clear that the fire distribution and intensities have remained essentially unchanged during the intervening five minutes. The most prominent hanging objects, which are barely visible in Figure 9-24, also seem to be at the same locations. The similarity of Figure 9-16 and Figure 9-24 indicates that comparisons of the infrared images with Figure 9-16 are justified since they were most likely recorded during the period between the two photographs.

**Figure 9-24.** This cropped photograph shows the north face of WTC 2 at 9:19:19 a.m. The image has been enhanced by adjusting the intensity levels, and column and floor numbers have been added.

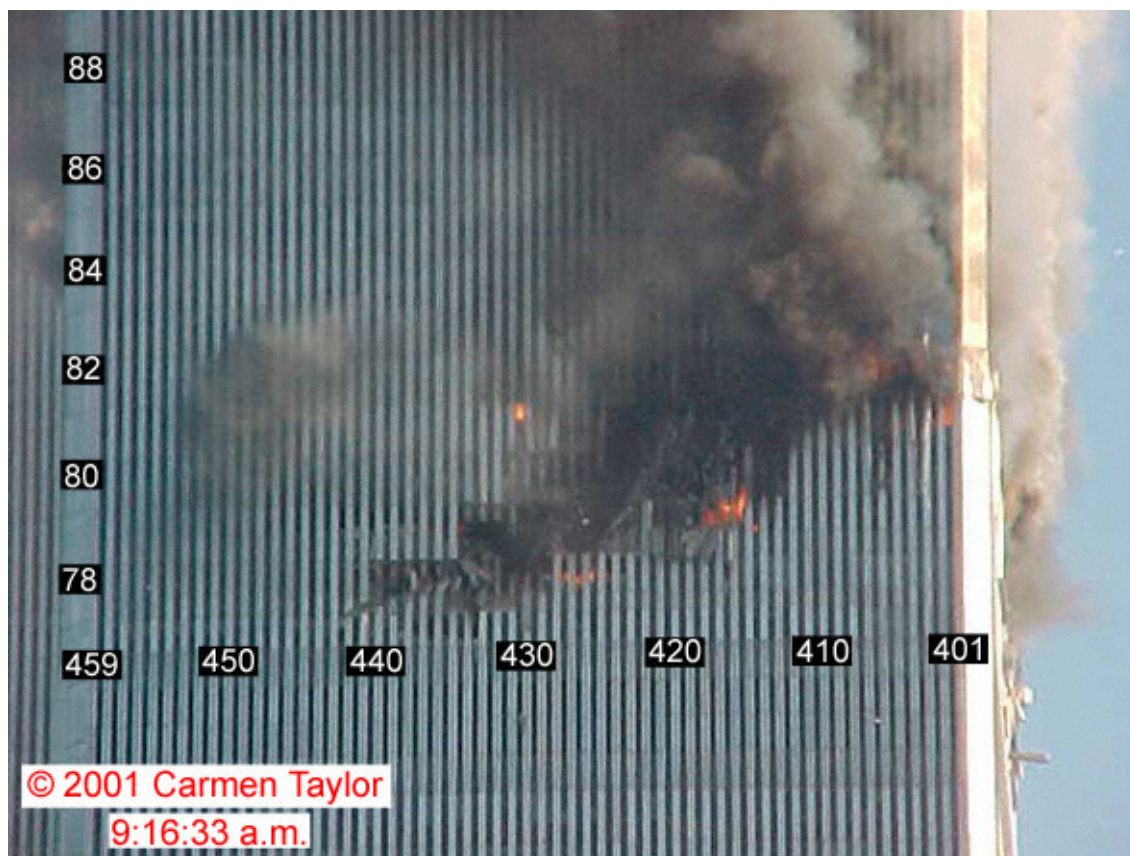
Figure 9-25 shows a view of the south face of WTC 2 recorded at 9:16:33 a.m. Comparison with Figure 9-18, which was recorded almost five minutes earlier, indicates that both the fire distributions and fire intensities have changed during this time. The most obvious change is the growth of a substantial fire on the 79th floor at windows 79-414 to 79-417. Consistent with earlier observations for fires on this face, it appeared at a location immediately adjacent to the aircraft impact cavity.

The fires on the east side of the face on the 81st and 82nd floors have also changed substantially. On the 81st floor, the fire intensity over most of the area has decreased noticeably, and the amount of smoke coming from the open windows has also decreased. The exception is window 81-401, where flames, which were not prominent at the earlier time, now fill the window. In the earlier photograph most of the windows on the 82nd floor were hidden by smoke coming from the 81st floor, and no flames were visible. It was noted in the last section that a distant video taken just prior to 9:15 a.m. showed that the fire on the 81st floor had died down and that a fire had become visible just above on the 82nd floor. At 9:16:33 a.m. these flames are visible in window 82-401 to window 82-408, and flames are extended from the windows in the center part of this length.

Two fires remain visible to the west of the aircraft impact cavity on the 79th and 81st floors. In both cases their intensity appears to have decreased during the five minute period. Meanwhile, the fire on the east side on the 79th floor next to the aircraft impact cavity seems to have grown larger.

Figure 9-25. This photograph shows the south face of WTC 2 at 9:16:33 a.m. The south face of WTC 1 is visible to the left of the western edge of WTC 2. Column and floor numbers have been added.

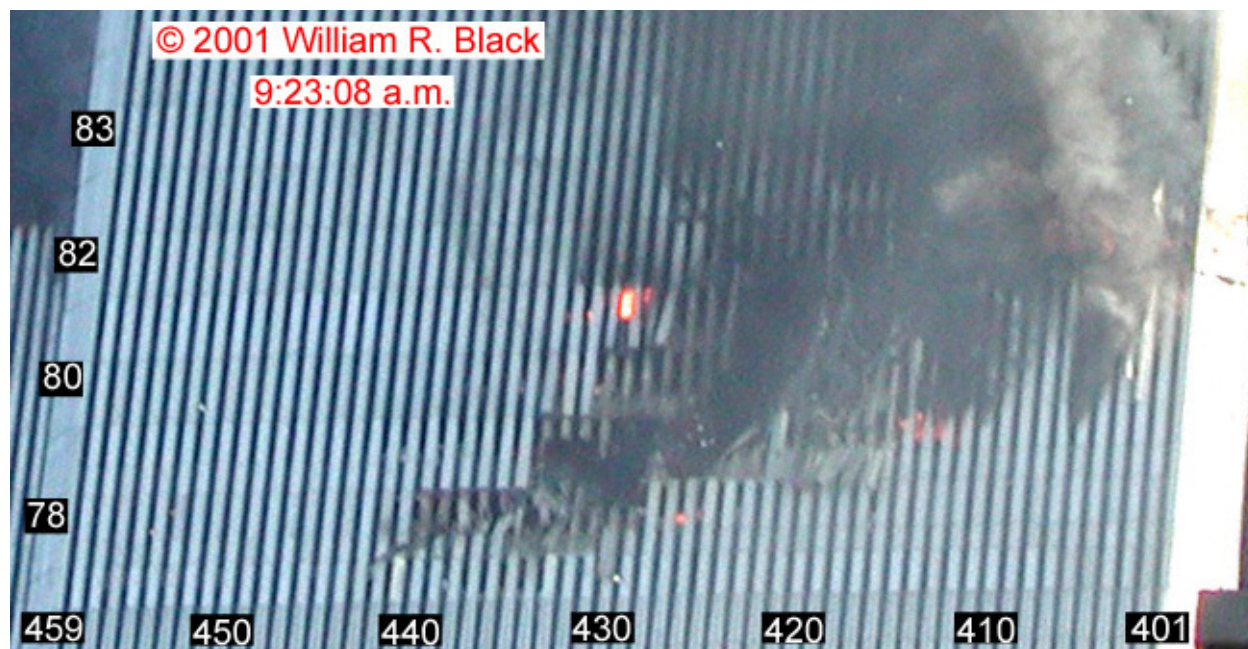
A later view of the south face taken at 9:23:08 a.m. is shown in Figure 9-26. During the nearly seven minutes since Figure 9-25 was shot, the fire that had appeared on the east side of the aircraft impact cavity on the 79th floor has grown and spread toward the east. The most intense flames are now observed in windows 79-413 to 79-415, and heavy smoke is coming from windows 79-411 and 79-412. At the earlier time flames were coming out of windows 79-415 to 79-417, and heavy smoke was coming from windows 79-412 to 79-414. A heavy smoke flow is also coming from window 79-406 at the later time.

The fires on the east sides of the 81st and 82nd floors have similar appearances in the two photographs. The same is true for the lower intensity fire burning on the 78th floor just to the east of aircraft impact cavity. The small fire to the west of the aircraft impact cavity on this floor is still, just barely, visible. The fire higher up on the 81st floor has grown brighter and now extends over windows 81-429 to 81-433. Comparison with Figure 9-10 and Figure 9-18, which were shot at 9:06:31 a.m. and 9:11:17 a.m., respectively, indicates that this fire has not spread significantly, but that its intensity seems to fluctuate with time.

Figure 9-26. This cropped photograph shows the south face of WTC 2 at 9:23:08 a.m. The image has been rotated and enhanced by adjusting the intensity levels. Column and floor numbers have been added.

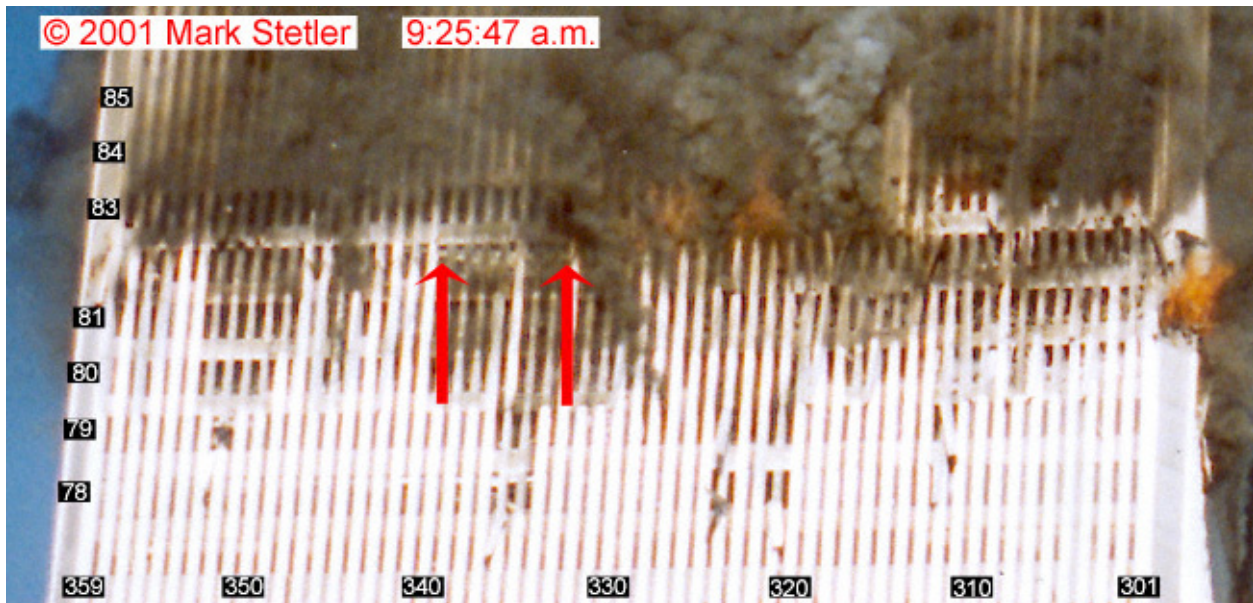
A photograph of the east face of WTC 2 at 9:25:47 a.m. is shown in Figure 9–27. This image was taken 7 min and 9 s later than the similar photograph reproduced in Figure 9–21. Arrows added to the figure indicate the hanging object observed earlier through windows on the 82nd floor. Its appearance has changed substantially from earlier times (compare with Figure 9–1, Figure 9–2, and Figure 9–21). In the vicinity of window 82-336, it is now visible lower down in the open windows. The hanging object no longer has the appearance of a thin line, but now looks like a curved sheet since the top of the object has been revealed. On either side of the dip the object remains high in the windows and still has the appearance of a line.

**Figure 9-27. View of the east face of WTC 2 recorded at 9:25:47 a.m. The original photograph has been cropped and enhanced by adjusting intensity levels. Column and floor numbers have been added. The arrows highlight a hanging object (floor slab) observed through open windows on the 82nd floor.**

By comparing Figure 9–6, Figure 9–14, and Figure 9–21 with Figure 9–27, it is apparent that the fire that grew on the south side of the east face on the 82nd floor shortly after the aircraft impact has continued spreading to the north. Intense flames are now coming from windows 82-321 to 82-329, while the fires have died down in windows further to the south. Heavy smoke is coming from windows as far north as window 82-316.

The fire distributions also changed at other locations on the east face between the times when Figure 9–21 and Figure 9–27 were taken. At the earlier time there was a large fire visible on the 82nd floor in windows 82-305 to 82-312 on the north side. By 9:25:47 a.m. this fire appears to have died down, and flames are no longer evident in this area. A flaming region is now present immediately above on the 83rd floor. Flames are visible on this floor in windows 83-302 to 83-312. In the earlier photograph heavy smoke was coming from these windows, but flames were not as evident. The fire burning in the northeast corner of the 81st floor appears to have decreased somewhat in intensity during the period. The heaviest flames are now coming primarily from the opening on the northeast corner of this floor. Even in this area, the flame lengths have decreased somewhat. It is now possible to barely discern the corner column 82-300, which is still in place, through the opening on the 82nd floor.

In Figure 9–27, the heaviest smoke is coming from windows on the 82nd and 83rd floors, and the lower floors are visible. A smoke plume is flowing from one of the windows, 79-227, on the 79th floor where there appears to be some flame visible, and light smoke can be seen exiting from a few other windows on the lower floors. Nevertheless, the general impression is that of little smoke flowing from floors lower than the 82nd. As mentioned above, this conclusion is somewhat misleading since brief periods of smoke release from lower floors had been observed starting before 9:13 a.m. Review of videos and photographs showed that these smoke releases increased in both frequency and the amount of smoke released as time progressed.

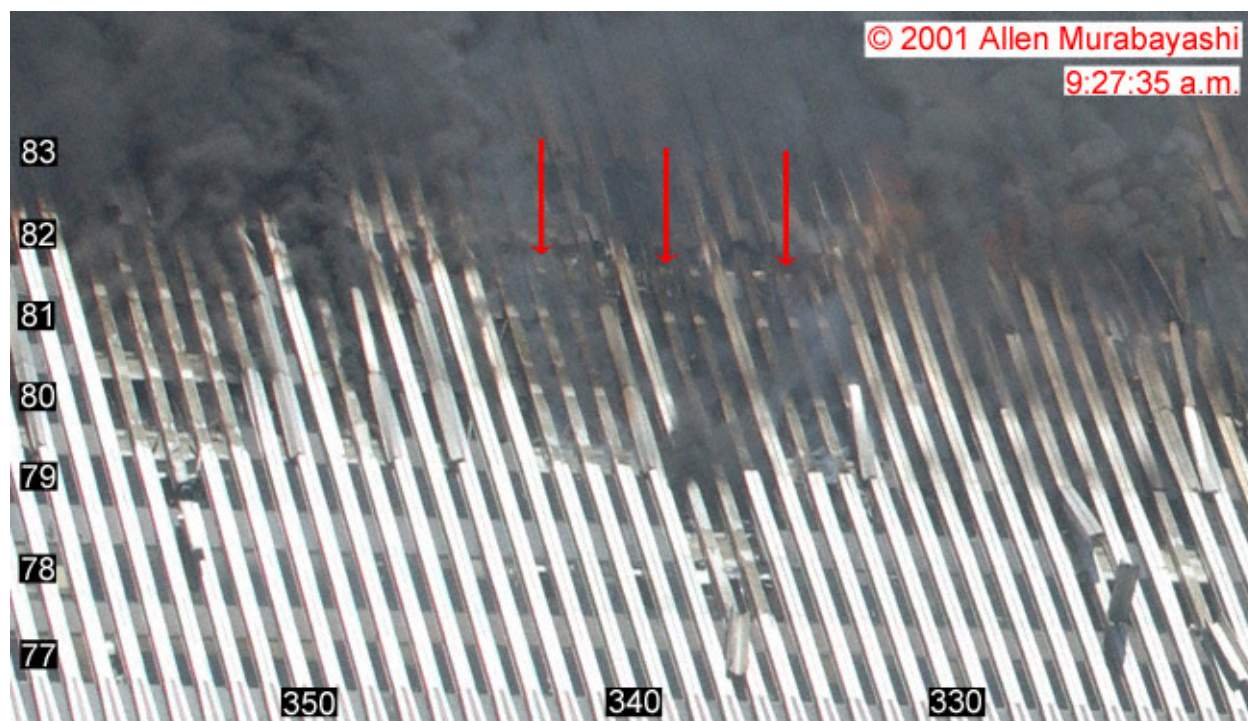
Another view of this object, shot from a different angle, is shown in Figure 9–28. This photograph was taken from a location on a nearby street to the southeast of the tower. As a result, the photograph is looking up at the hanging object from below. The arrows indicate the object. An enlarged view of the area with the object is shown in Figure 9–29. From this angle the object also has a sheet-like appearance, but, unlike in Figure 9–27, the underside of the object is in view. This is most easily seen in window 82-332. The sheet-like structure of the object is that which would be expected if the hanging object were a portion of the 83rd floor slab that, after having been dislodged from the east perimeter wall, had settled down further below the open windows on the 82nd floor. This closer view shows that the object was visible as far south as window 82-342 at this time. At earlier times the object was visible further to the north than in Figure 9–27, but these windows remain hidden by dark smoke.

Figure 9-28. This cropped photograph shows the east face of WTC 2 at 9:27:35 a.m. The original image has been rotated, and column and floor numbers have been added. The arrows highlight a hanging object observed through open windows on the 82nd floor.

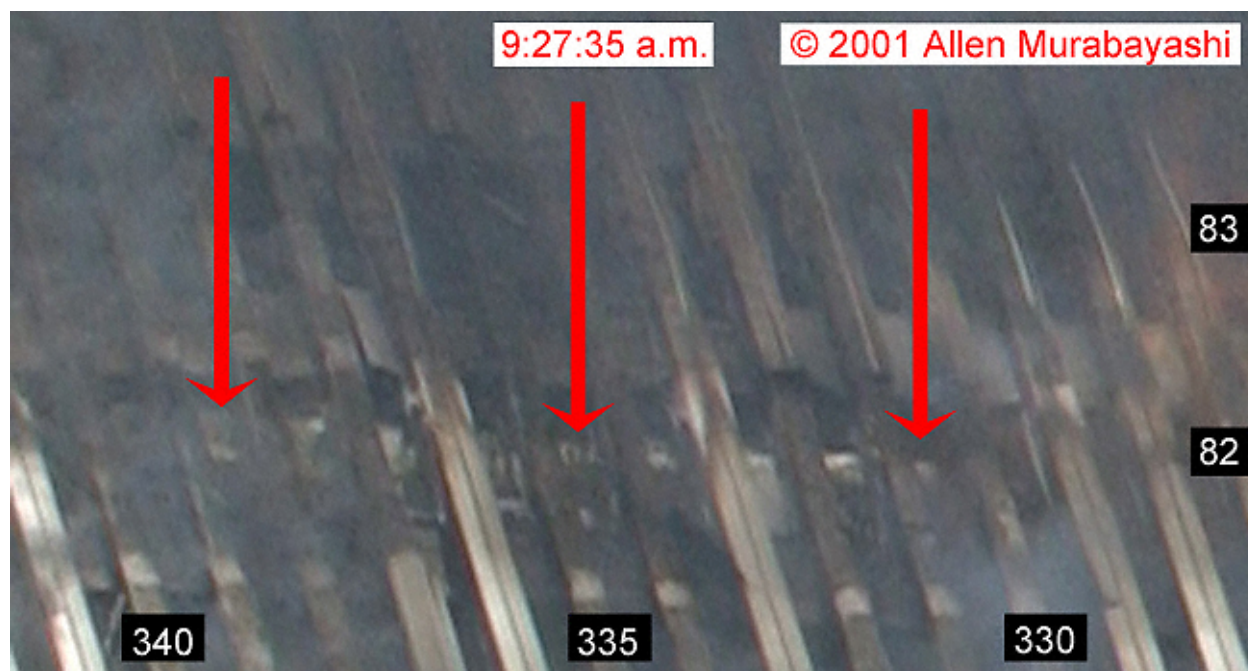
Figure 9-29. This image is an enlargement of a portion of Figure 9-28 showing the east face of WTC 2, where a hanging object is visible through open windows on the 82nd floor. Column numbers have been added.

The arrows in Figure 9–40 indicate the hanging object that was described earlier. The appearance of the object is much the same as in Figure 9–28, which was shot from a similar angle at 9:27:35 a.m. This indicates that the portion of the object that is visible has not moved a great deal in the intervening period.

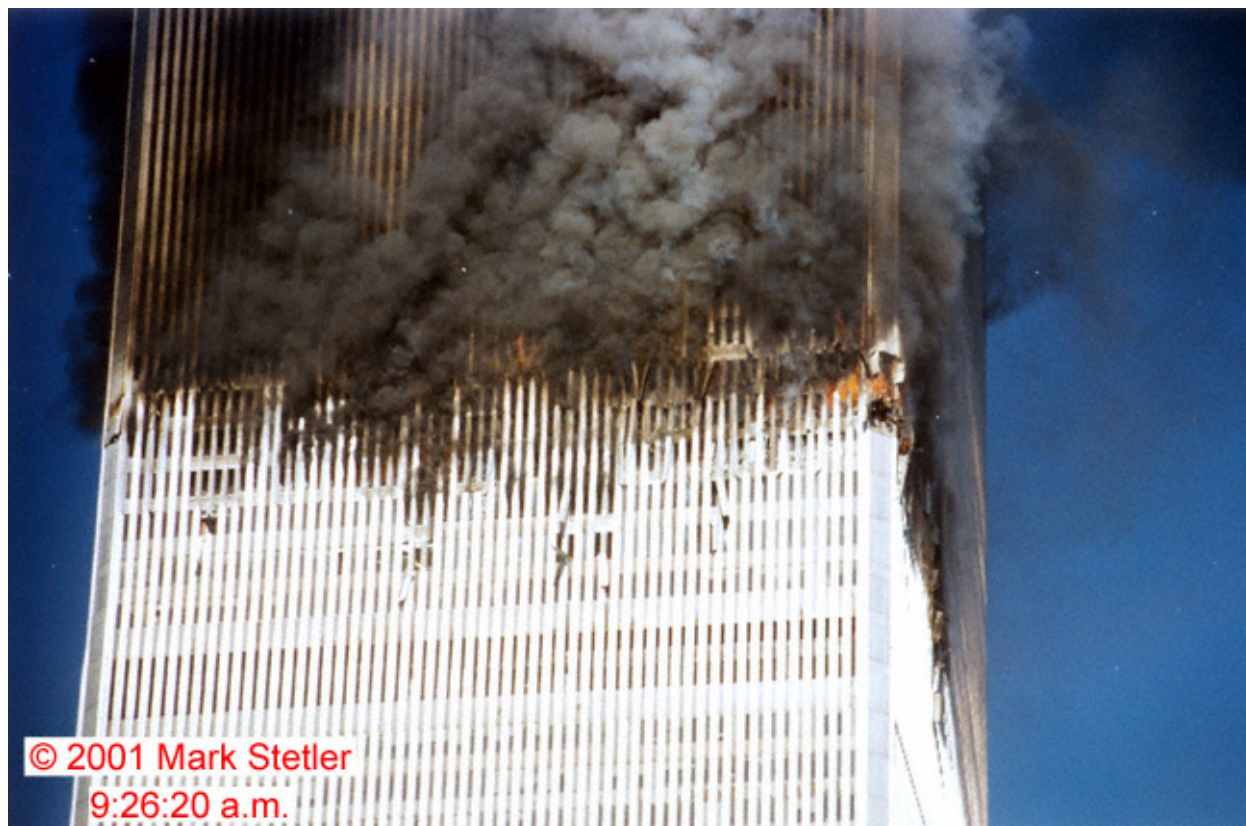
**Figure 9-30. This photograph showing the east face of WTC 2 was taken at 9:26:20 a.m.**

Comparison of Figure 9–27 with Figure 9–30 and Figure 9–31 provides an indication of how quickly the appearance of the east face could change during the smoke release events. In Figure 9–30 heavy smoke almost completely obscures the hanging object seen clearly less than a minute earlier through the 82nd floor windows. This smoke had been pushed out of open windows on the 79th through 82nd floors. In the blowup of the south side of the face in Figure 9–31, the hanging object is just visible at the tops of windows 82-329 through 82-333, as indicated by the arrow placed on the lower image in Figure 9–31. A small fire is visible at the top of window 82-229 above the object.

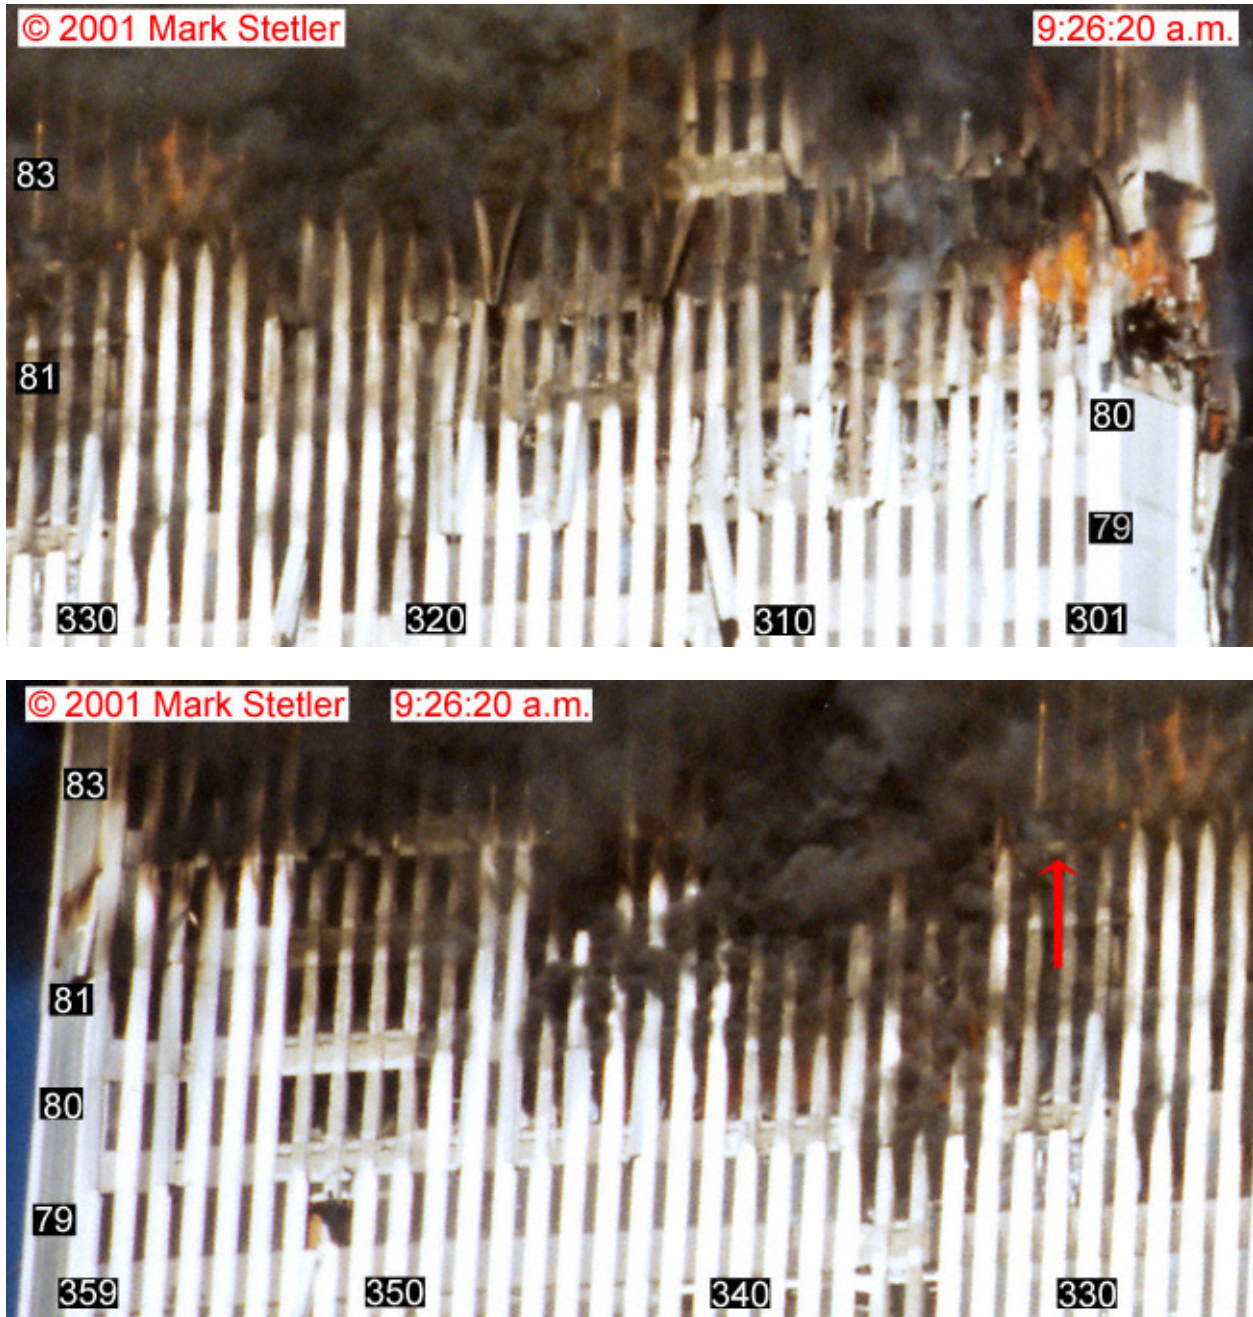
In this photograph (see lower image in Figure 9–31) the heaviest smoke flow on the 79th floor is from windows 79-333 to 79-336, but lighter smoke is also flowing from windows 79-320 to 79-325, 79-327, and 79-328. The glass is still in place for the intermediate windows where no smoke is observed, as well as on either side of windows 79-320 and 79-336. A long-distance video of the smoke release indicates that the relative density of smoke flowing from these windows varied rapidly with time and location and that heavy smoke was pushed from the other open windows during a portion of this release.

In Figure 9-31 smoke is also coming from open windows at the southern end of the east face on the 80th, 81st, and 82nd floors. Unlike on the 79th floor, flames as well as smoke are visible on the 80th floor in windows 80-333 to 80-340. Fire was present in this vicinity as early as 9:07:04 a.m. (see Figure 9-7). It has apparently grown slowly during the intervening 20 min. A small fire is also visible in window 81-335 on the 81st floor.

The heavy flames coming from windows 82-321 to 82-329 on the 82nd floor 33 s earlier in Figure 9-27 have retreated back into the windows. In Figure 9-31 extended flames are only visible in windows 82-326 and 82-327. The intense fire on the northern edge of the 83rd floor in Figure 9-27 has also died down. In particular, the flames that filled windows 83-310 to 82-312 earlier appear to have completely dissipated in Figure 9-31. The appearance of the fire burning on the northeast corner of the 81st floor has also changed. At the earlier time large flames were visible coming from the opening on the northeast corner. Thirty-three seconds later, the fire covered a much broader extent of the debris in the corner, while the flames in the northeast corner opening appeared to have died down. A long-distance video of this corner around this time shows that the intensity of the fire on the 81st floor was highly variable.

**Figure 9-31.** These two images show blowups of the north and south sides of the east face of WTC 2 taken from the photograph included in Figure 9-30, which was shot at 9:26:20 a.m. Column and floor numbers have been added. The arrow highlights a hanging object visible through open windows on the 82nd floor.
